## PARLIAMENT BUILDING QUÉBEC – CANADA

The restoration works on the Québec Parliament Building started on 5th October 2005, 110 years after the initial instalment of the cornice.

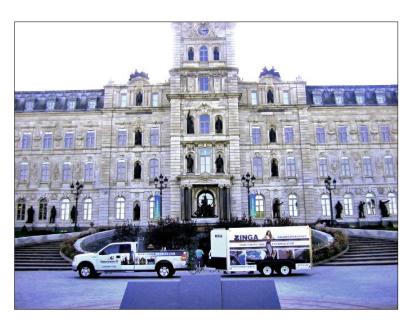
This is a picture of the mobile **ZINGA** unit ready to start recoating the cast iron railings at **the Parliament Building in Quebec City!**

System: ZINGA 2 x 60 μm DFT + 2 layers PU coating
