## SCHWENK CEMENT FACTORY – BERNBURG – GERMANY

In 1992 the new plant of the cement factory **SCHWENK** in Bernburg was protected with **ZINGA**.  
Application technique: airless spraying.  
These pictures were taken during construction.  
**30 tons of ZINGA** were used for this application.

Cement factory SCHWENK at Bernburg /East Germany / Inspections on ZINGA after over 10-years after application and submission under rough production conditions.

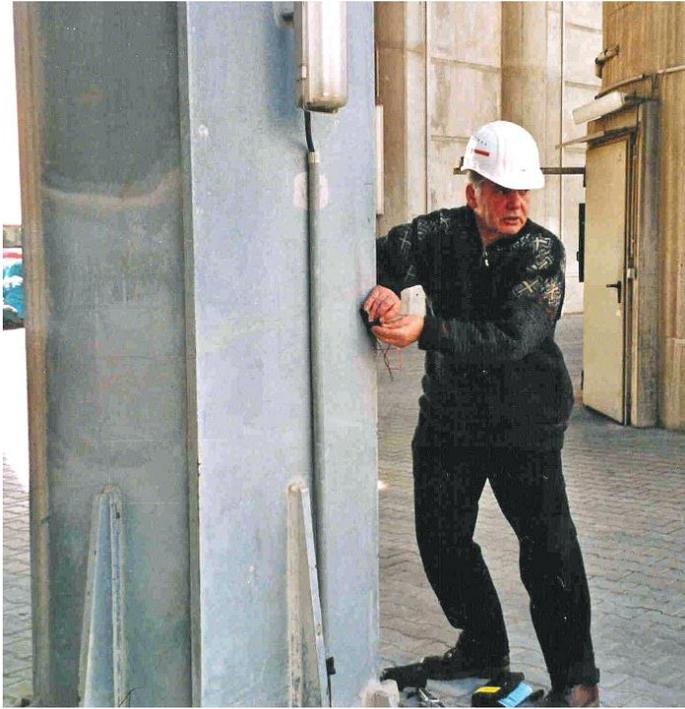
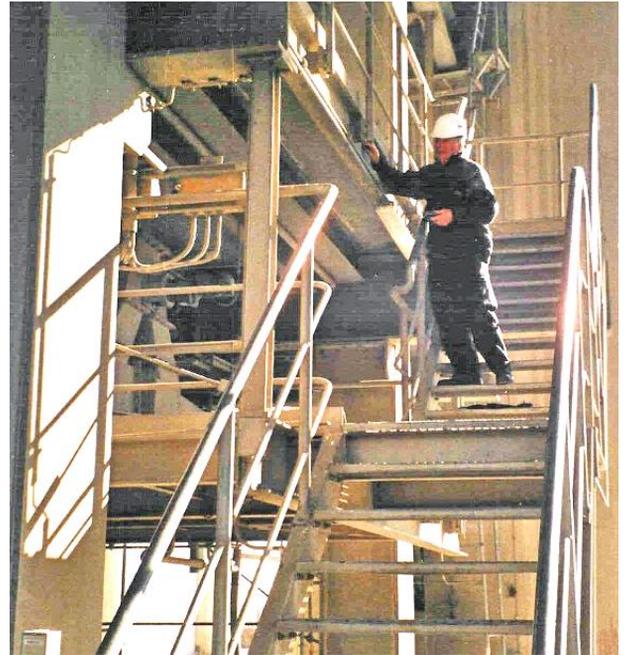
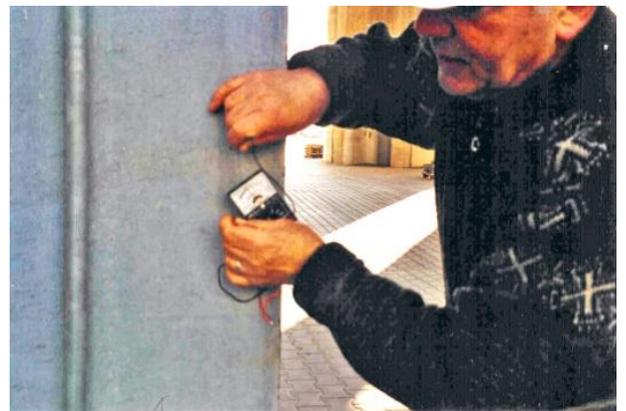
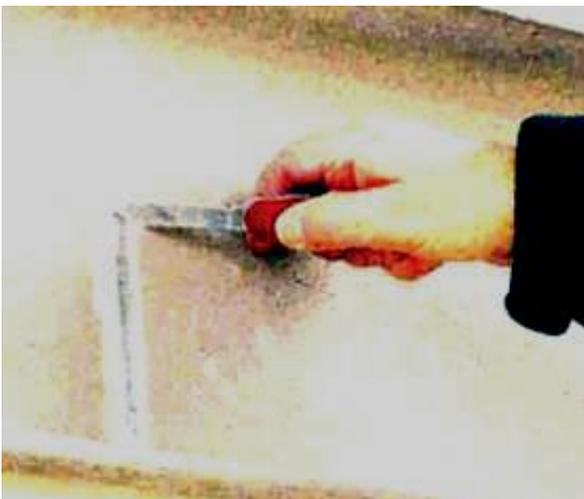
In February 2003, the condition of the **ZINGA** layer was inspected. On the pictures you can see that the **ZINGA** is still in perfect condition and shows no trace of rust **after more than 10 years**.

On the weathered side of the plant, where abrasive media and rain are washing the surface, the **ZINGA** layer thickness had decreased from 120  $\mu\text{m}$  to 70  $\mu\text{m}$ . This comes down to 5  $\mu\text{m}$  a year, which is surprisingly good under these hard environmental conditions.

At this moment there is no need for touch-ups. Later on, the **ZINGA** can very easily be recharged simply by applying a new layer on top of a cleaned surface !

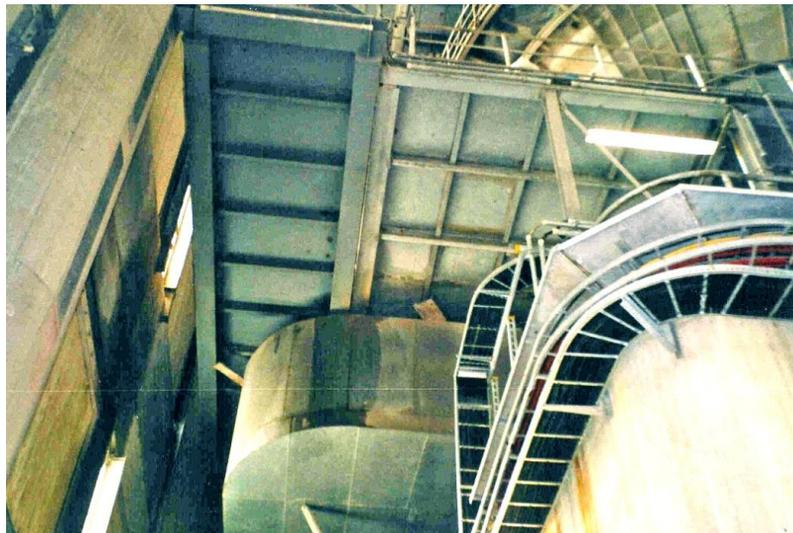
The dark grey on the upper installation is **ZINGA**, and is found to be in perfect condition. The light grey is hot-dip galvanizing, where rust begins to appear.
