SUNKEN GARDENS - KENSINGTON PALACE LONDON – UNITED KINGDOM

The **SUNKEN GARDENS of KENSINGTON PALACE** in London (°1908) underwent their first refurbishment after 200 years, with several trees being cut down and most of the others being trimmed right back. New trees were planted and then hundreds of *hooped frames* were installed with the new growth being trained over the frames for the trees to form a natural tunnel around the gardens.

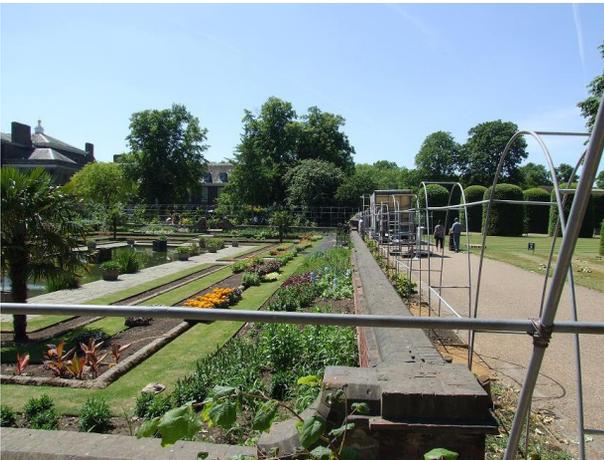
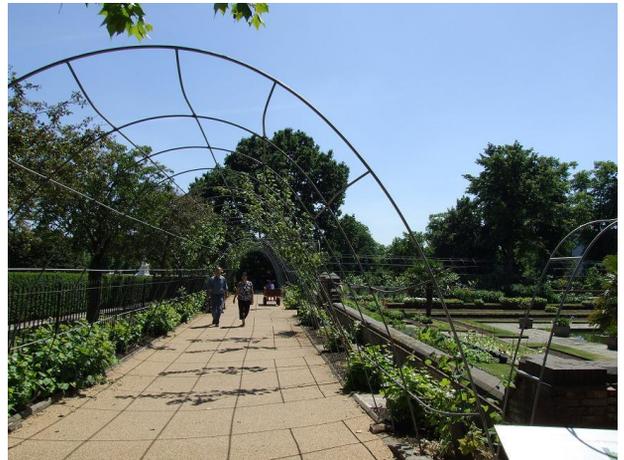
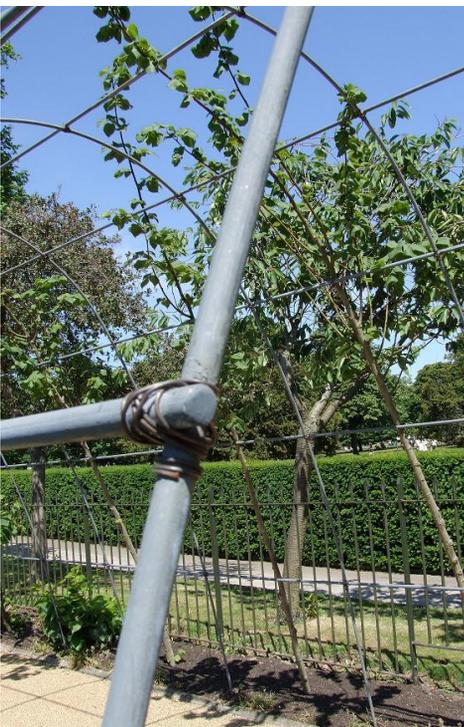
All the photographs below clearly illustrate the following facts:

1. The frames were tied together with wire as opposed to being welded together to maintain a natural look.
2. There are hundreds of hoops made of 16mm round steel bar and they were mounted all around the gardens.

1. Every hoop had to be leveled individually by digging holes and back-filling under and onto the base-plates.
2. Due to the blast-cleaning process being too awkward on curved sections, the hundreds of steel lengths were coated with **ZINGA** and then cold-rolled through a rolling machine.
3. The hoops are not perfect semi-circles but have straight sections on every hoop. These were hammered into final shape by the blacksmiths from Badger Forge.
4. After all the rolling and hammering operations had been completed, the Zinganised surfaces were all still in perfect condition.

Surface preparation:
 SA2,5 and Rz 80µm

ZINGA

2 x 60 µm DFT
