BRIDGE over the BLANICE River – CZECH REPUBLIC

In August 1993, an 80 year old metal bridge over the Blanice River (40 km eastwards from Prague) was sand-blasted and only one layer of **ZINGA** was applied. There was not budget left for applying a second layer.

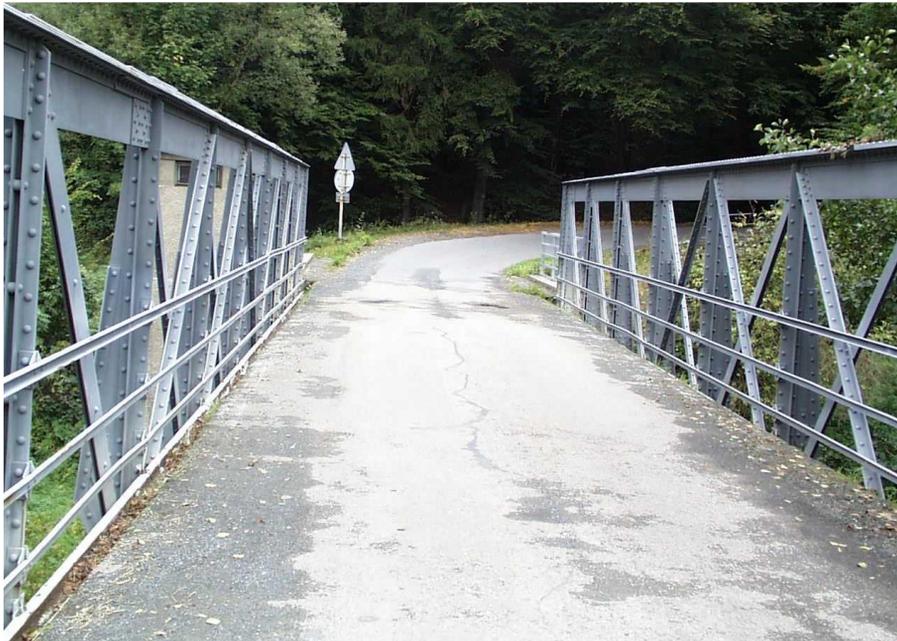
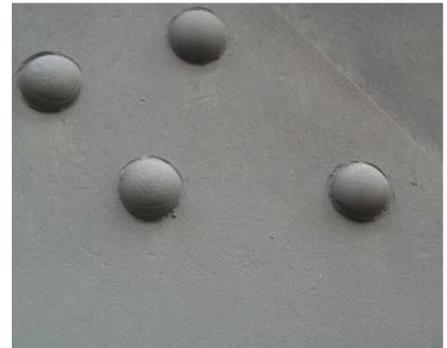
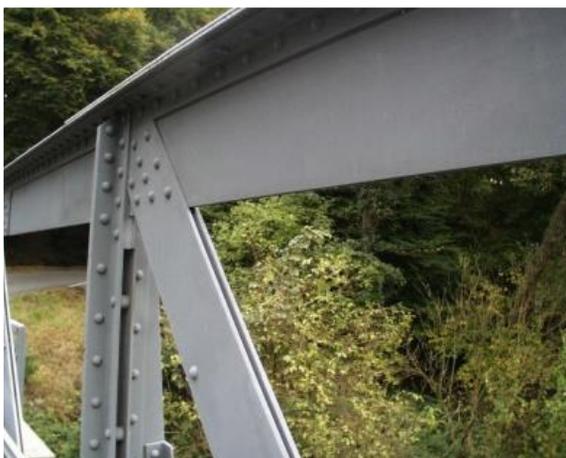
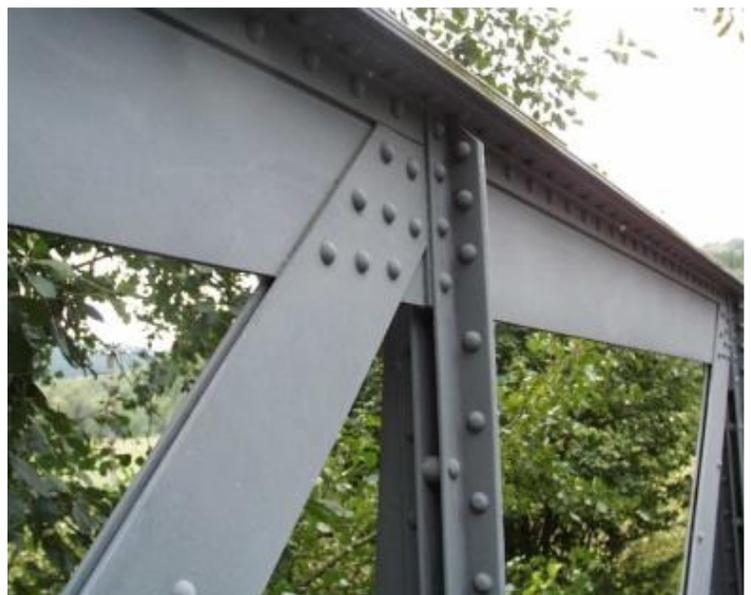
On 19-09-2000, **7 years after the ZINGA application**, the layer thickness was measured by Mr. Michal Stavar from the inspection company **GRANE**.

He measured an average of 40 µm to 55 µm DFT.

Which means that there was no significant decrease in layer thickness after 7 years.

System:
ZINGA 1 x 50 µm EFS
