CATTLE- AND PIGFARMS – FINLAND

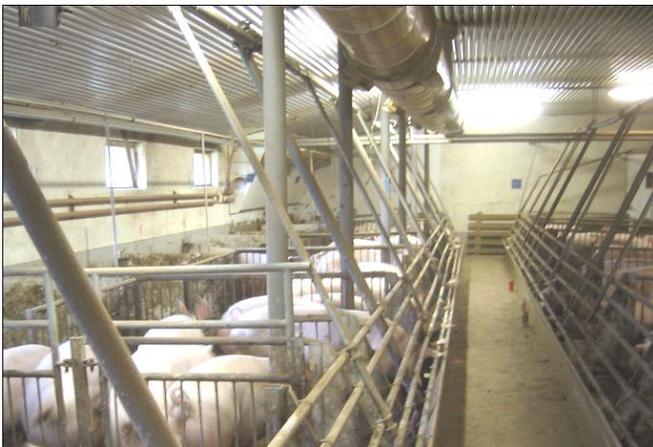
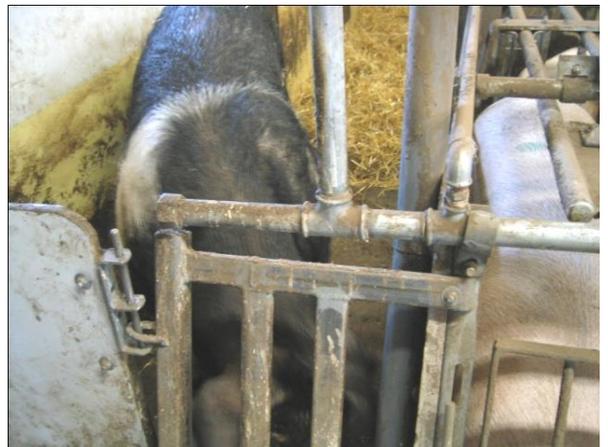
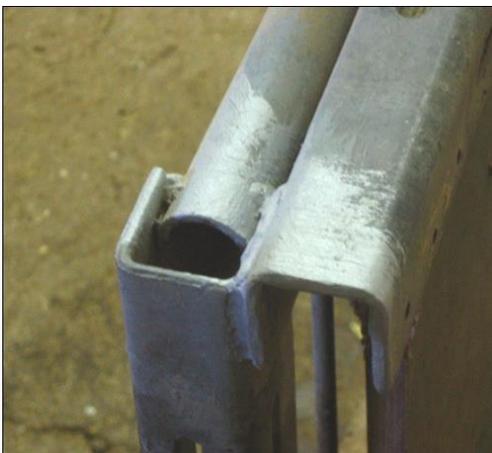
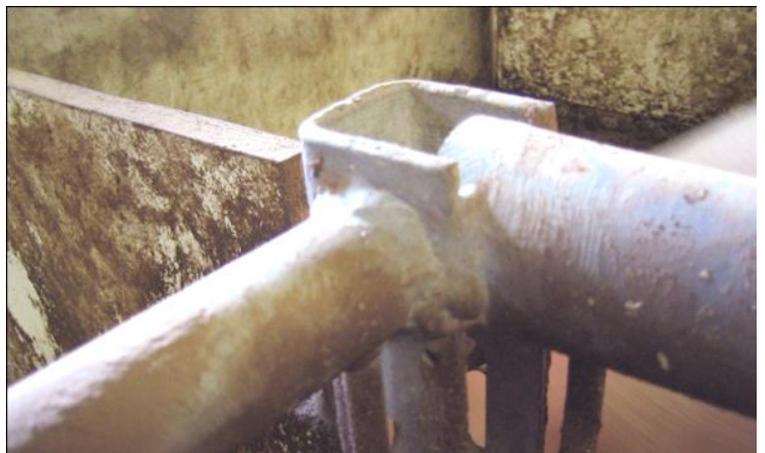
Surfaces are sandblasted to at least SA 2,5 and **ZINGA** is applied:

- to normal areas 1 x 50 µm DFT
- fittings at floor level are treated with 3 to 4 layers of 50 µm which offers an even longer lasting surface.

System:

ZINGA

1 to 4 x 50 µm DFT
