WILCO TRUCK & TRAILER FRAMES - HØNEFOSS - NORWAY

The **WILCO** Company (Mr. Nils HAFNOR) in Hønefoss, Norway, is making truck & trailer frames. All year long Norway and the other Scandinavian countries can be hit by very cold winters (but also by very hot summers) and they use a lot of road salt in the winter season. This is why they are using ZINGA as their basic corrosion protection since many years.

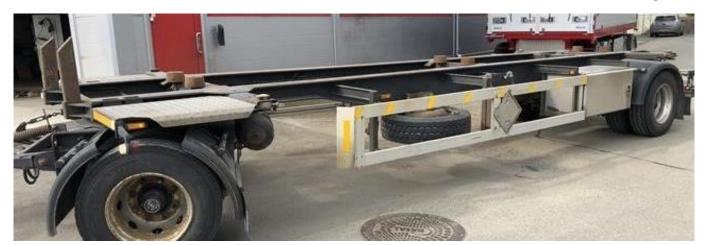
These rusted brackets were not protected with ZINGA

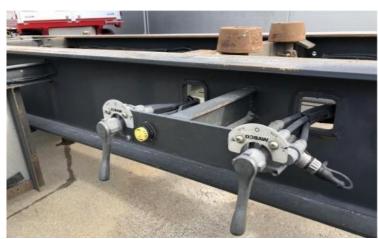
zingA was used in 2007 for this frame. These pictures were taken in 2018.

Surface preparation: Blasting to SA 2,5 ZINGA $1 \times 60 \mu m$ DFT Topcoat (different brands) $2 \times 100 \mu m$ DFT

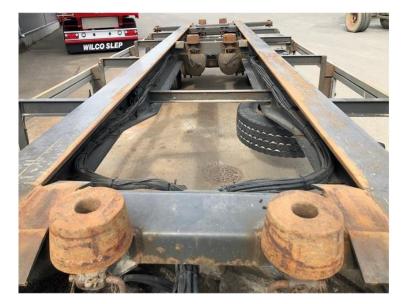
This frame was built in December 2010. These pictures were taken **10 years after**, in October 2020, after having traveled 1,000,000 km! (the heavy rusted parts are with a traditional paint system.)
